Management Report

Aztec Properties
Countryside Center
380 N Terra Cotta Road, Crystal Lake, IL

**Countryside Center
380 N Terra Cotta Road
Crystal Lake, IL**

Inspection Date: 05/01/2015
Inspector: Juan Acosta

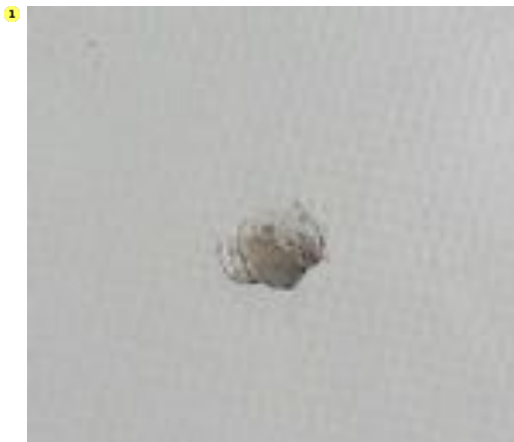
General - Puncture (Emergency)

Quantity: 15 EA

Deficiency:

Punctures/rips/tears through roof surface allowing water entry to roof system.

Corrective Action:

Repair all punctures/rips/tears throughout roof surface per industry/manufacture specifications.

Estimated Repair Cost:

\$1,450.00

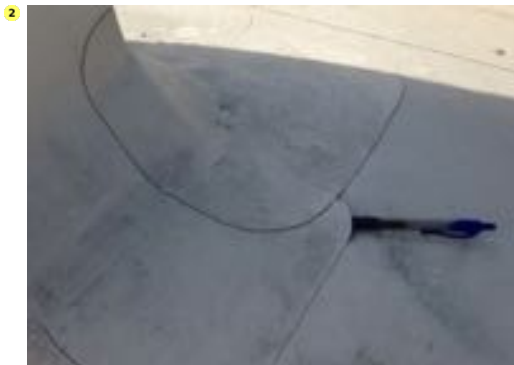
General - Open Seams (Remedial)

Quantity: 5 EA

Deficiency:

Open seams in the membrane are typically caused by failing seam adhesives coupled with membrane shrinkage and stress on the seams.

Corrective Action:

Repair and reinforce open seams per manufacturer specifications.

Estimated Repair Cost:

\$450.00

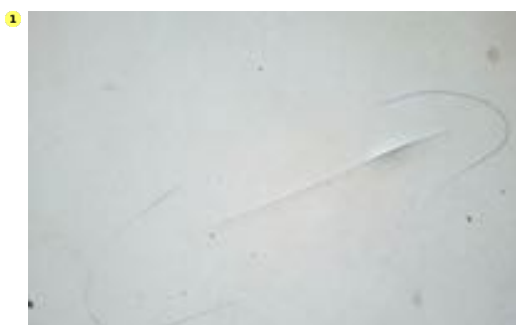
General - Punctures/Rips/Tears (Emergency)

Quantity: 12 EA

Deficiency:

Punctures/rips/tears through roof surface allowing water entry to roof system.

Corrective Action:

Repair all punctures/rips/tears throughout roof surface per industry/manufacture specifications.

Estimated Repair Cost:

\$1,000.00

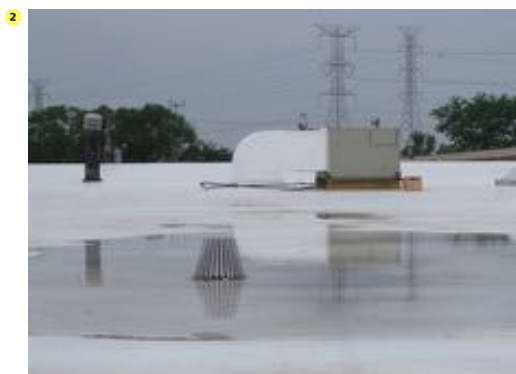
Single-Ply - Ponding (Remedial)

Quantity: 250 SF

Deficiency:

A ponding water condition is typically due to a flaw in how the original roof was designed and installed. The underlying insulation may have collapsed due to age or weight and created a low lying area on the roof which is now holding water.

Corrective Action:

Monitor areas of ponding water annually for premature membrane failure.
