Management Report

Aztec Properties
Countryside Center
380 N Terra Cotta Road, Crystal Lake, IL

**Countryside Center
380 N Terra Cotta Road
Crystal Lake, IL**

Inspection Date: 05/01/2015
Inspector: Juan Acosta

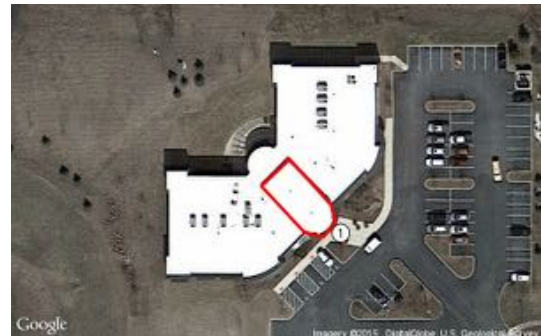
General - Puncture (Emergency)

Quantity: 15 EA

Deficiency:

Punctures/rips/tears through roof surface allowing water entry to roof system.

Repair all punctures/rips/tears throughout roof surface per industry/manufacture specifications.
